PROJECT PROFILE

Client: NSW Department of Education

Location: Zetland, NSW

NSW Department of Education, Green Square Demolition - Zetland, NSW

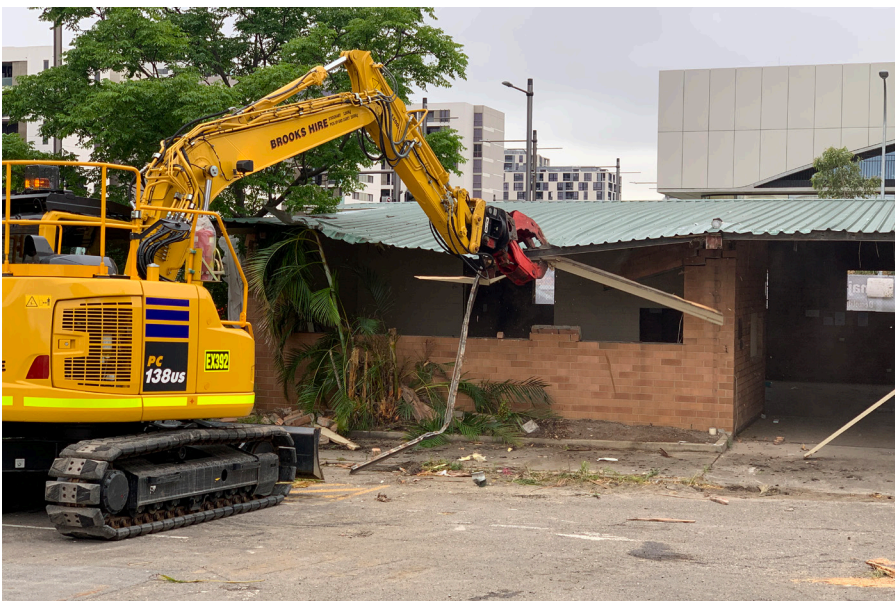
*Pic.1 -
Demolition of Green Square
Community Hall*

Due to limited and narrow access to the project site, MPG could only mobilise a 13t excavator for the demolition of the Green Square Community Hall. MPG demolished the Community Hall over a weekend, so that it could create a new site access for the mobilisation of other plant and equipment. MPG then removed all asbestos containing material in the Hydrotherapy Building and undertook all the strip out works prior to the hard demolition of the building.

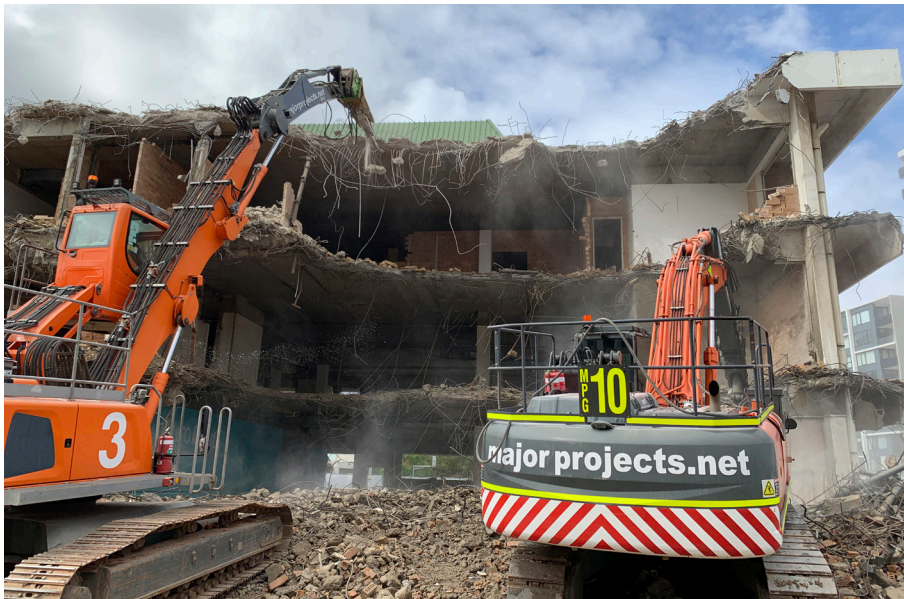
*Pic.2 -
Demolition of the
Hydrotherapy Building*

MPG used two 30t excavators for the 12m high Hydrotherapy building. The nearby substation had to be protected during the demolition of the Hydrotherapy building, as the decommissioning and demolition of it could only be performed at a later date. MPG used an engineered scaffolding design and demolition curtain (as shown in picture 4) to prevent debris from the demolition process damaging the live substation. Once MPG demolished the Hydrotherapy building, it also removed the building's basement and footings. Additionally, MPG undertook a ground scan to enable the future school ground work design.

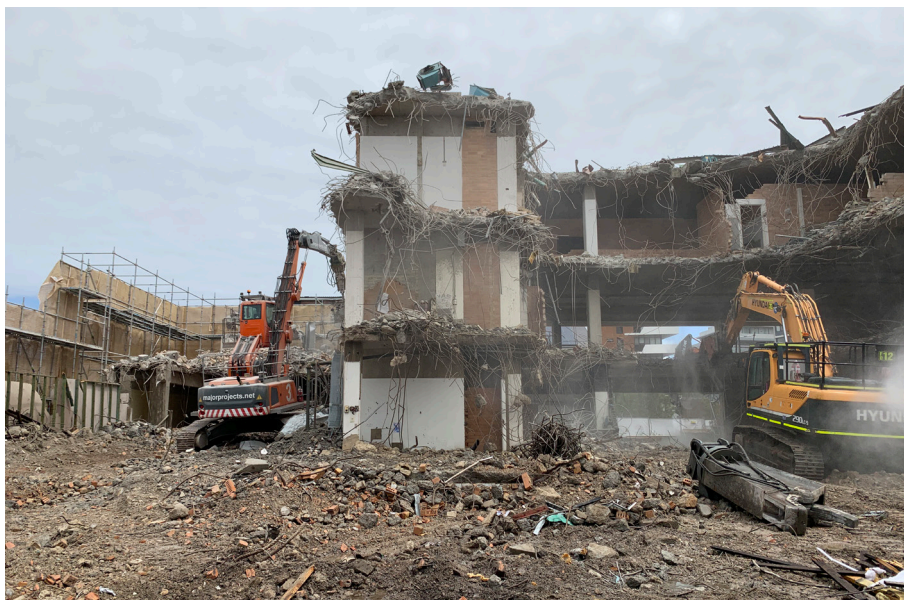
*Pic.3 -
Demolition of the
Hydrotherapy Building*

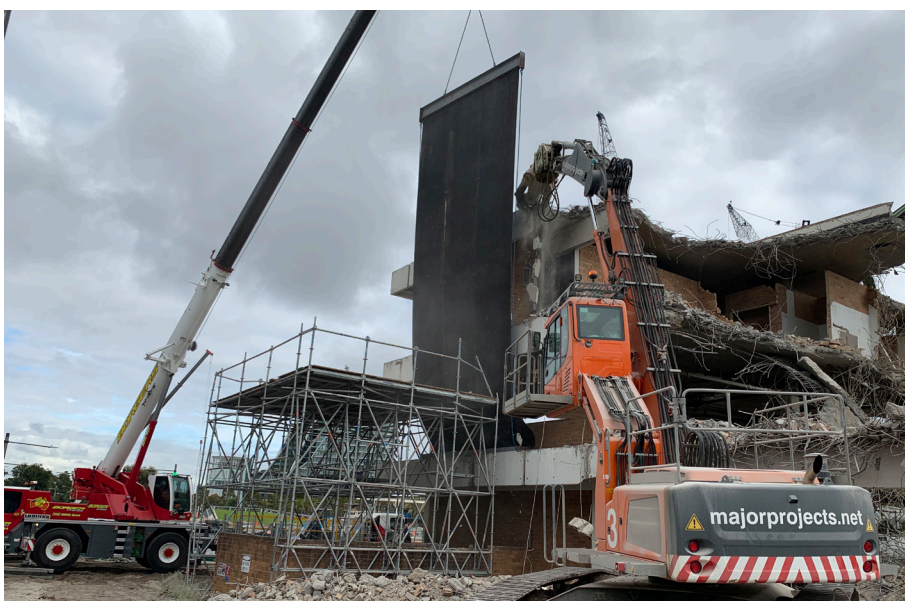
*Pic.4 -
Substation Protection*

- Short mobilisation window due to footpath and road closures;
- Protection of substation while undertaking the demolition of the Hydrotherapy Building. Temporary work design for scaffold crash deck and demolition curtain.
